Radiation hard electronics for HEP experiments: problems and solutions

Federico Faccio CERN / EP-ESE-ME

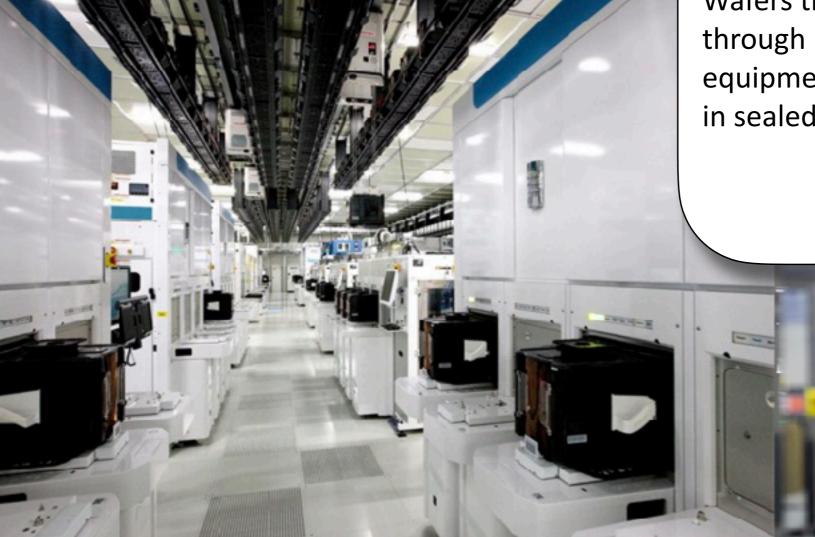
Look inside a giant "FAB"

Wafers travel through processing equipment in sealed vessels

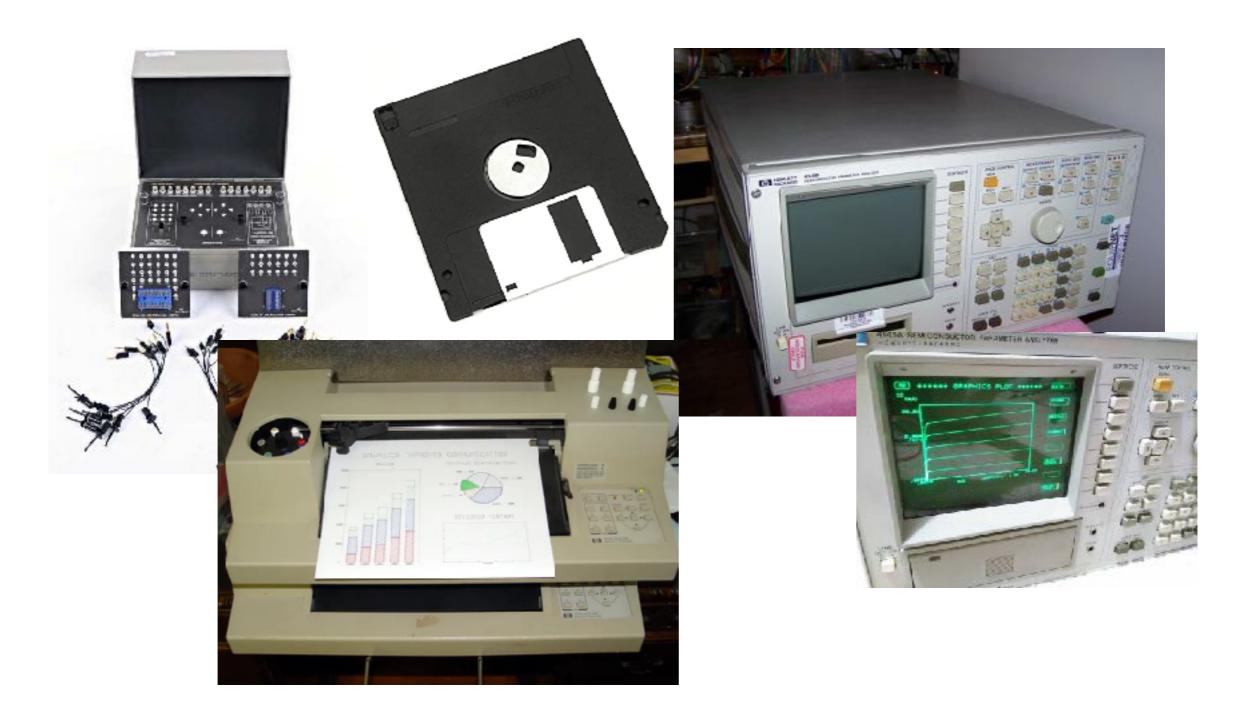
Measurements:

- Chips packaged in DIL
- Individual transistors manually connected sequentially
- Data saved on floppy disks
- Curves plotted with pencil plotter and interpolated manually to extract the parameters

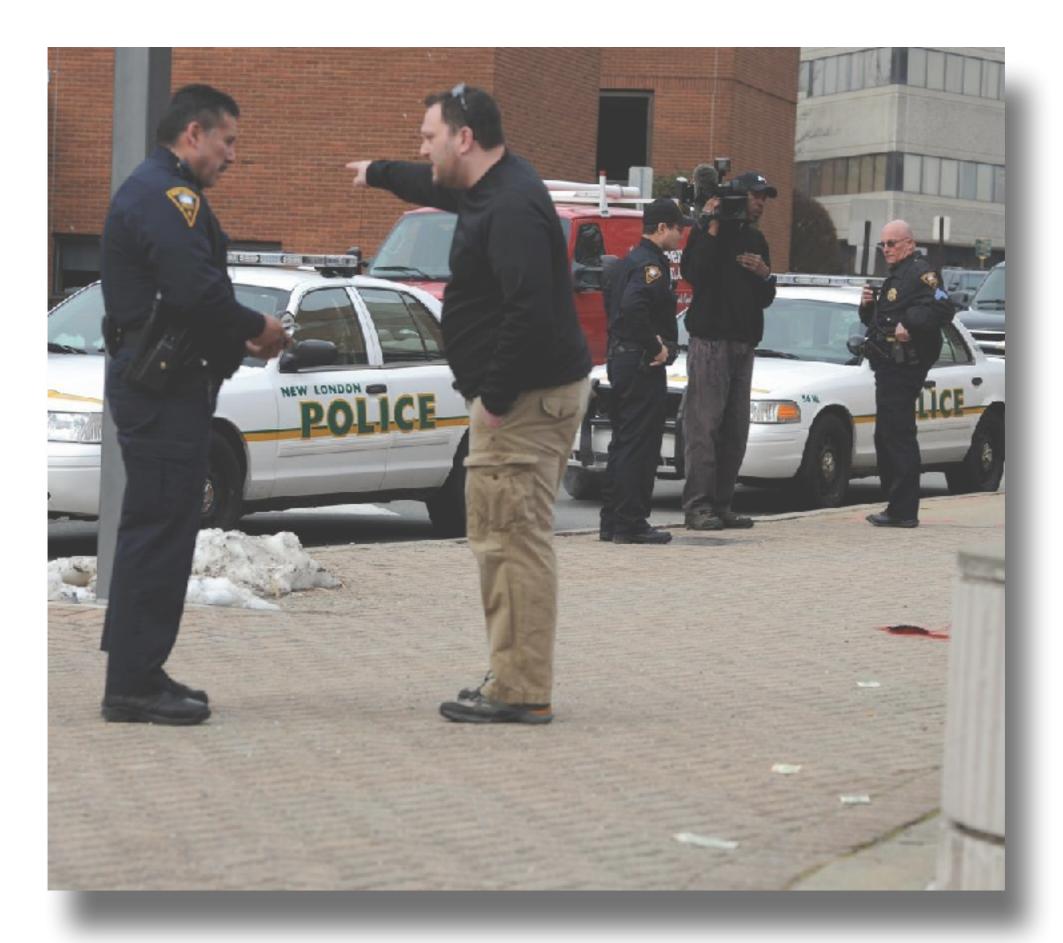
Failure of FEAST DCDCs in the CMS pixel detector

DCDCs fail during disable/enable cycles

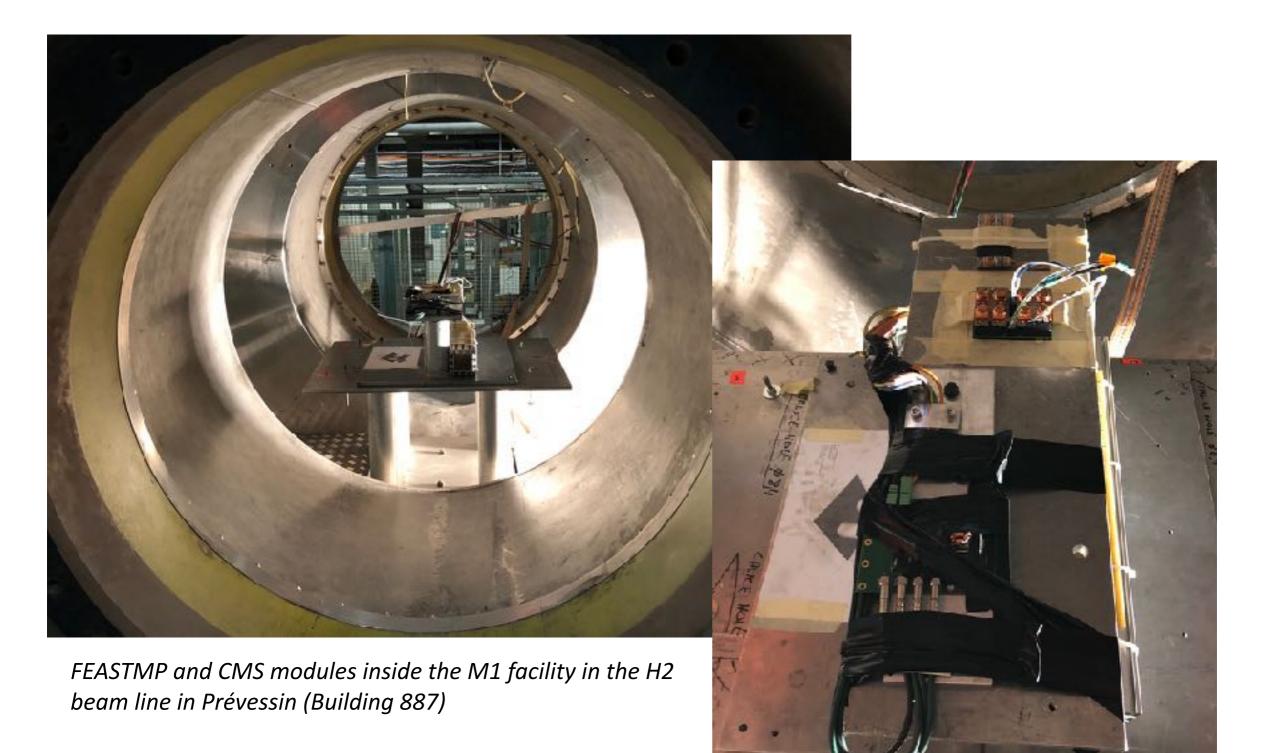
Test in a 3T magnetic field revealed no problem

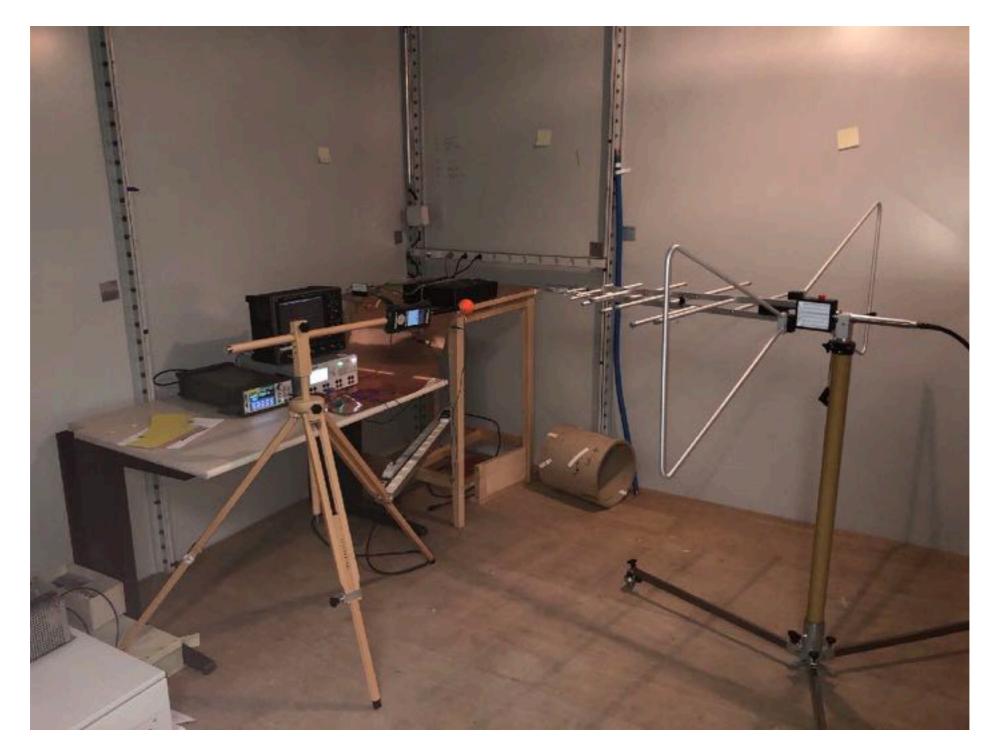
High frequency (GHz) and high power transient pulses are injected via an antenna in a special chamber in CERN Prévessin. At very large power, the ASIC can be damaged but the signature is different than in samples failing in CMS. Coupling is through the long enable line.

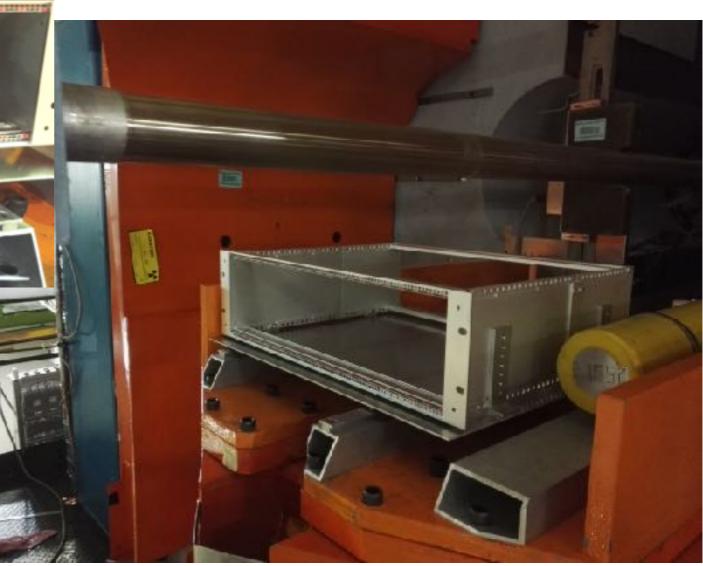
32 sample DCDC modules, both FEASTMP and CMS modules, are exposed and constantly monitored in the CMS Castor Table during the 2018 run.

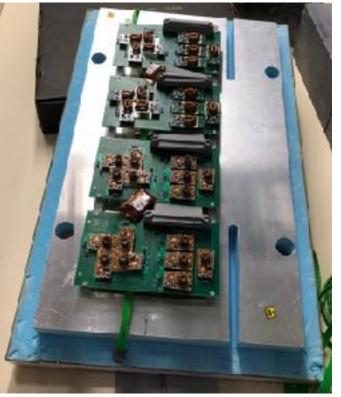
32 modules inside the cold box

32 samples, both FEASTMP and CMS modules, are exposed and constantly monitored in a cold box (-25°C) in the CERN IRRAD facility (May 2018).

A specific bias and control sequence was used during the exposure
